# **Afon Cynffig / Kenfig River Pollution Incident Independent monitoring findings 26 and 27 May 2026**

## **Prepared by A Peace for Nature**

This briefing summarises further independent environmental monitoring and site observations undertaken by A Peace for Nature on 26 and 27 May 2026 on the Afon Cynffig / Kenfig River downstream of the Marlas STW SPS outfall, North Cornelly.

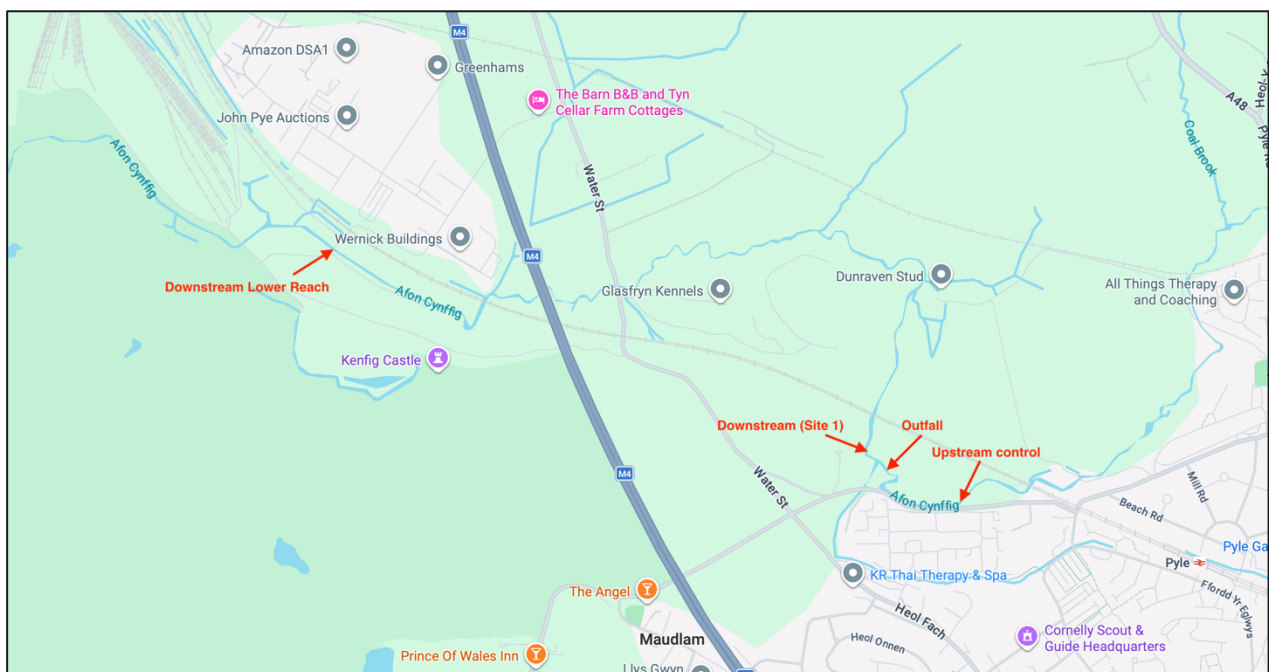
The same monitoring locations identified and used during previous site visits were used.

Upstream control	Upstream of the affected discharge reach ~300-400m
Outfall	Marlas STW SPS outfall discharge
Downstream (Site 1)	~100 m downstream from the outfall
Downstream lower reach	Lower affected reach ~3.2km downstream of the discharge
