**Afon Cynffig / Kenfig River
Pollution Incident
Independent monitoring findings
2nd June 2026**

Prepared by A Peace for Nature

This briefing summarises independent environmental monitoring and site observations undertaken by A Peace for Nature on 2 June 2026 on the Afon Cynffig / Kenfig River downstream of the Marlas STW SPS outfall, North Cornelly.

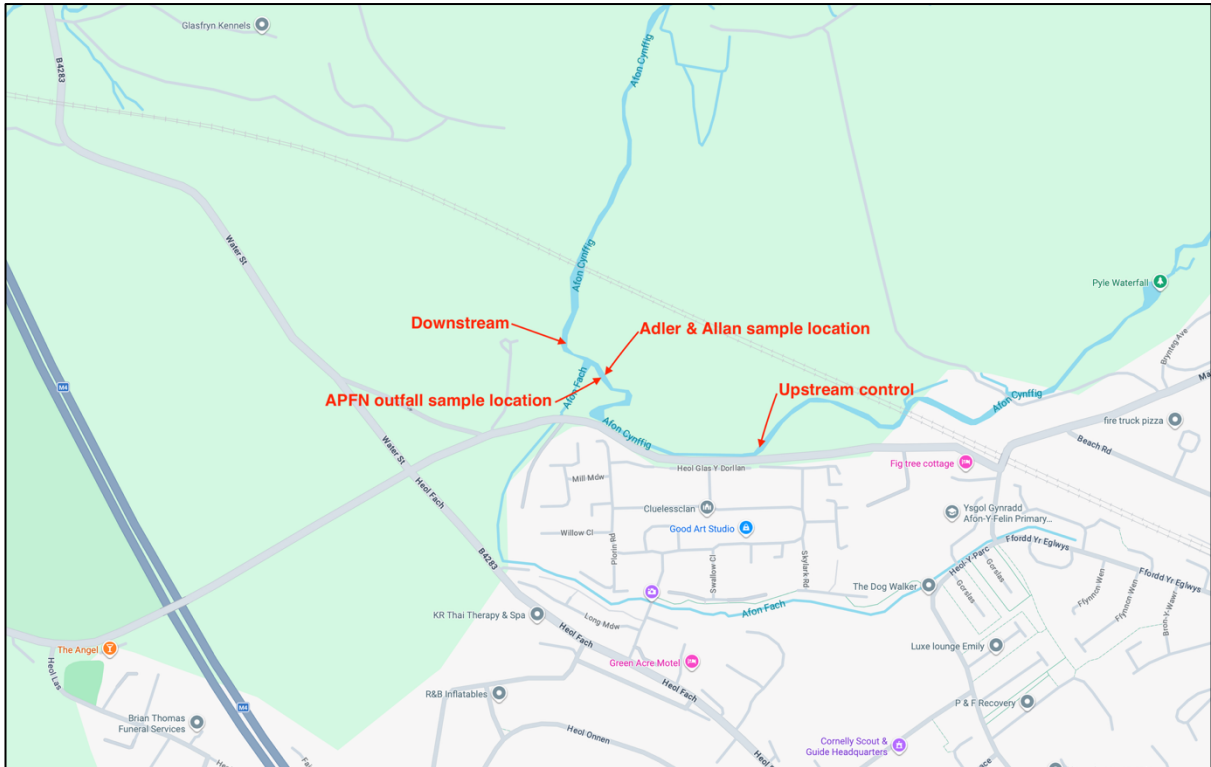
Figure 1: APFN sampling locations

The same monitoring locations identified and used during previous site visits were used. A further sample location was added (Adler & Allan sample location) for comparison of results.

Upstream control	Upstream of the affected discharge reach ~300-400m
APFN outfall sample location	Marlas STW SPS outfall discharge
Downstream	~100 m downstream from the outfall
Adler & Allan sample location	Opposite Marlas STW SPS outfall

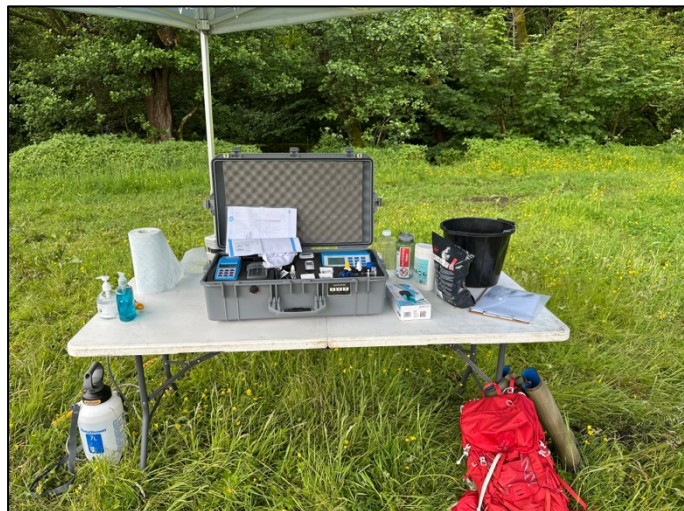
Figure 2: APFN field apparatus

A mobile field laboratory was established beneath a pop-up gazebo adjacent to the river. This arrangement provided shelter from light rainfall and maintained a cool and shaded environment for field analysis.

- Hanna Instruments HI83399 Multiparameter Photometer with COD capability
- Hanna Instruments HI98193 Dissolved Oxygen Meter
- Hanna Instruments HI98192 EC/TDS/NaCl/Resistivity Meter
- Hanna Instruments HI98713 ISO Turbidimeter
- Hanna Instruments pHep+ Portable pH Meter
- Clean sample collection containers
- Hanna Instruments consumable reagents for all tests undertaken
- GPS-enabled mobile device for recording sampling coordinates and photographic evidence

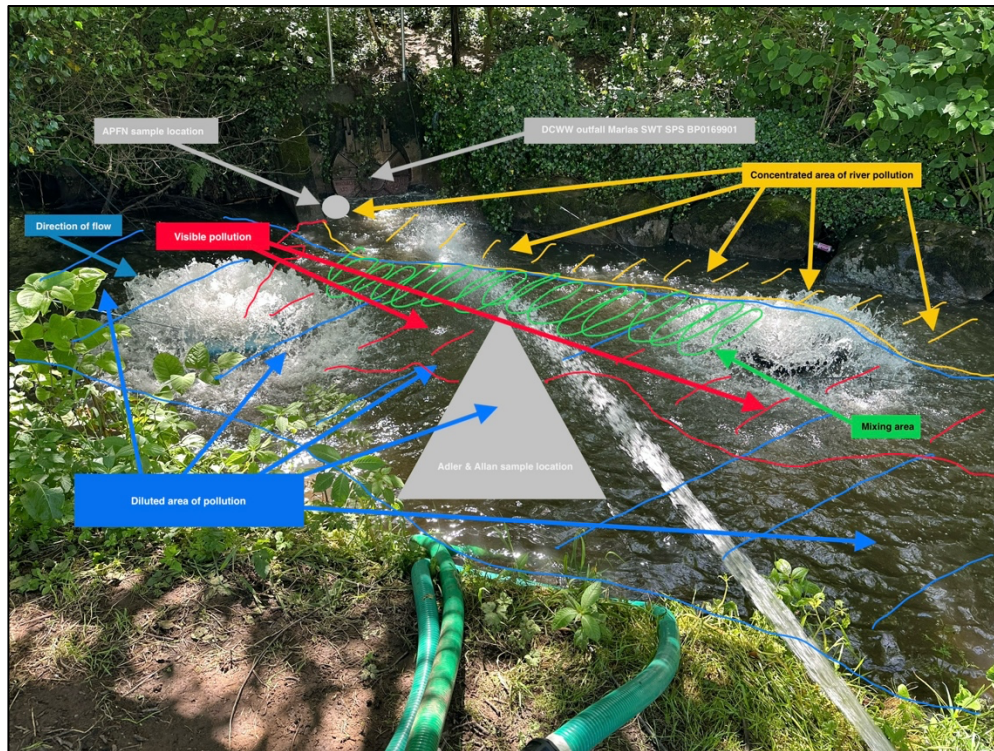
Figure 3: Relative positions of APFN and contractor sampling locations at the Marlas STW SPS outfall

Annotated site photograph showing the location of the Marlas STW SPS outfall, APFN direct outfall sampling point, contractor sampling location between the aeration devices and the observed areas of mixing and dilution within the receiving watercourse. Arrows are illustrative and intended to demonstrate the likely influence of mixing and aeration on water quality measurements obtained at different locations.

The contractor advised that samples were collected using a throw-bucket technique and confirmed that their sampling location was situated between the two aeration devices operating within the river (Figure 3).

APFN considers that sampling location has a significant influence on the results obtained and that samples collected following mixing, aeration and dilution within the river may not necessarily be representative of conditions at the discharge source itself.

Location: Between aeration devices (Figure 3) (comparative sample): Adler & Allan sample location

The comparative sample was collected from a location where the discharge had already undergone substantial mixing, dilution and aeration within the receiving watercourse.
