# A Peace for Nature Site Visit Report

6 July 2026

## Bedford Park Sewage Pollution Incident

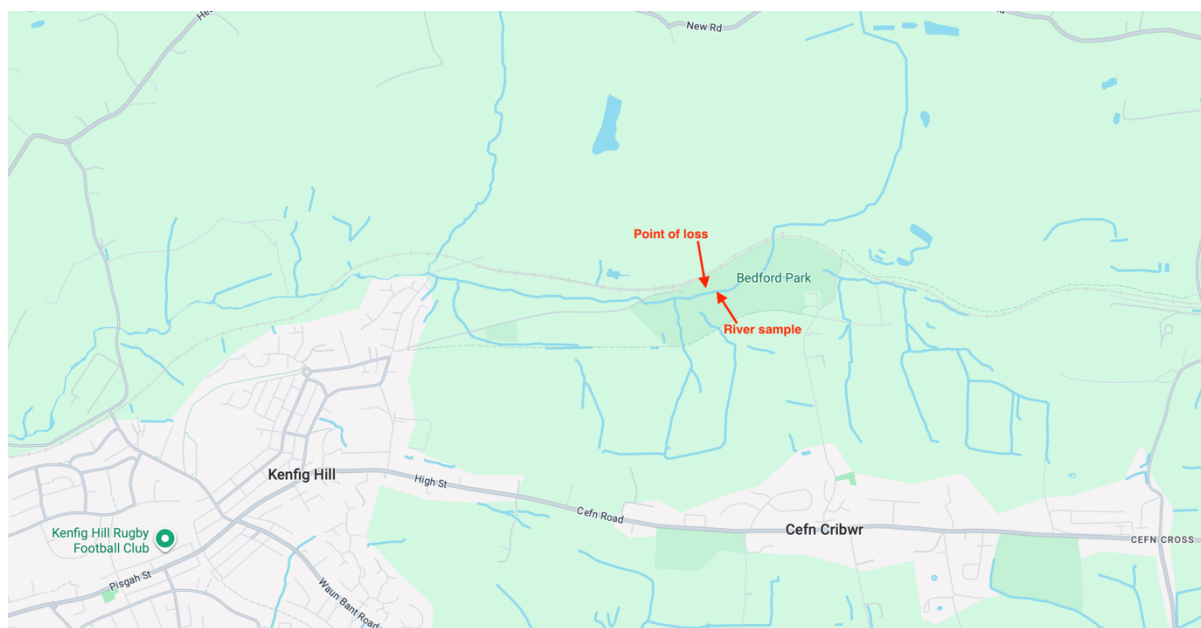
At the approximate location 51.538477, -3.659814, APFN observed an active discharge from what appeared to be a DCWW manhole / asset. The discharge was visibly sewage-related.

Toilet paper and whole faeces were present, and the smell was consistent with sewage.

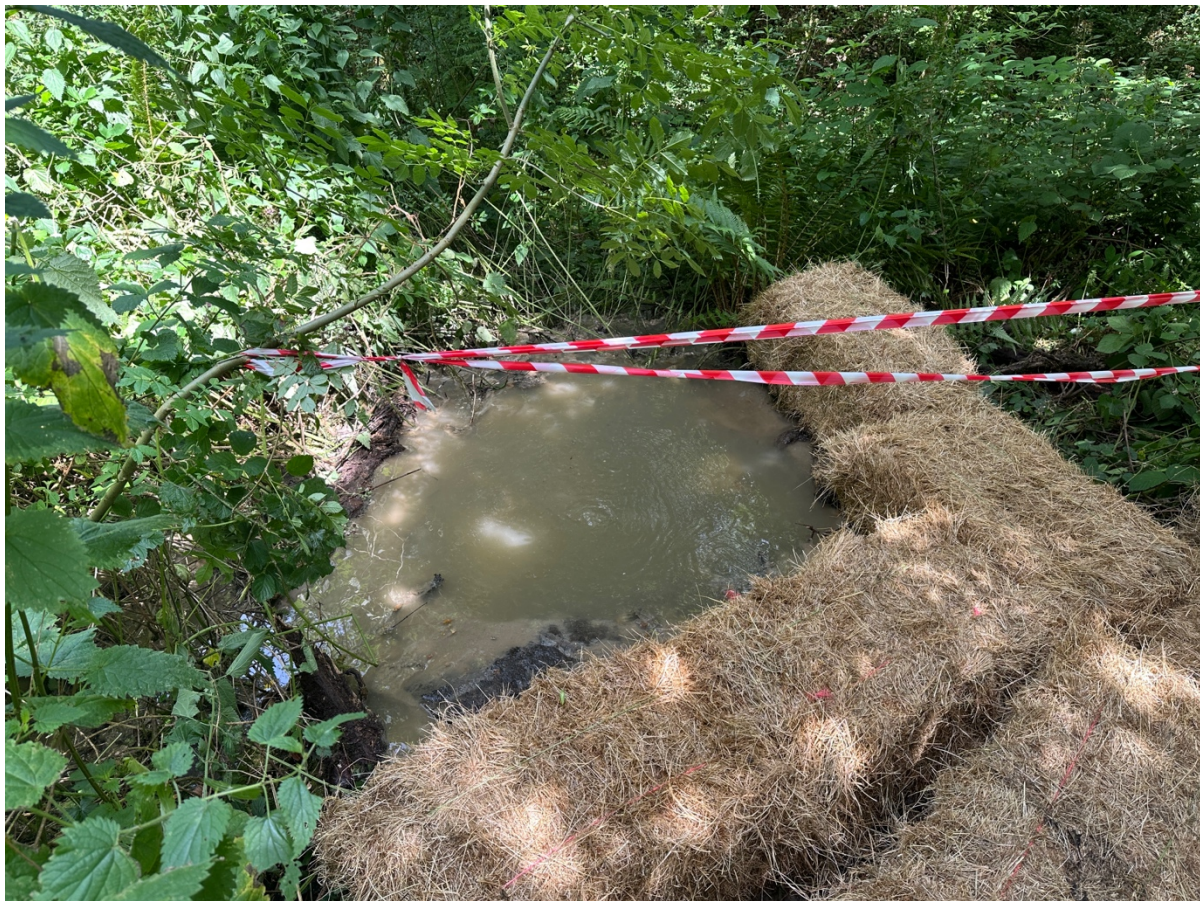
The discharge was flowing into a pooled area on land. APFN estimated the affected area to be approximately 5 metres wide and 50–80 metres long. Sewage-related material was visible within this area.

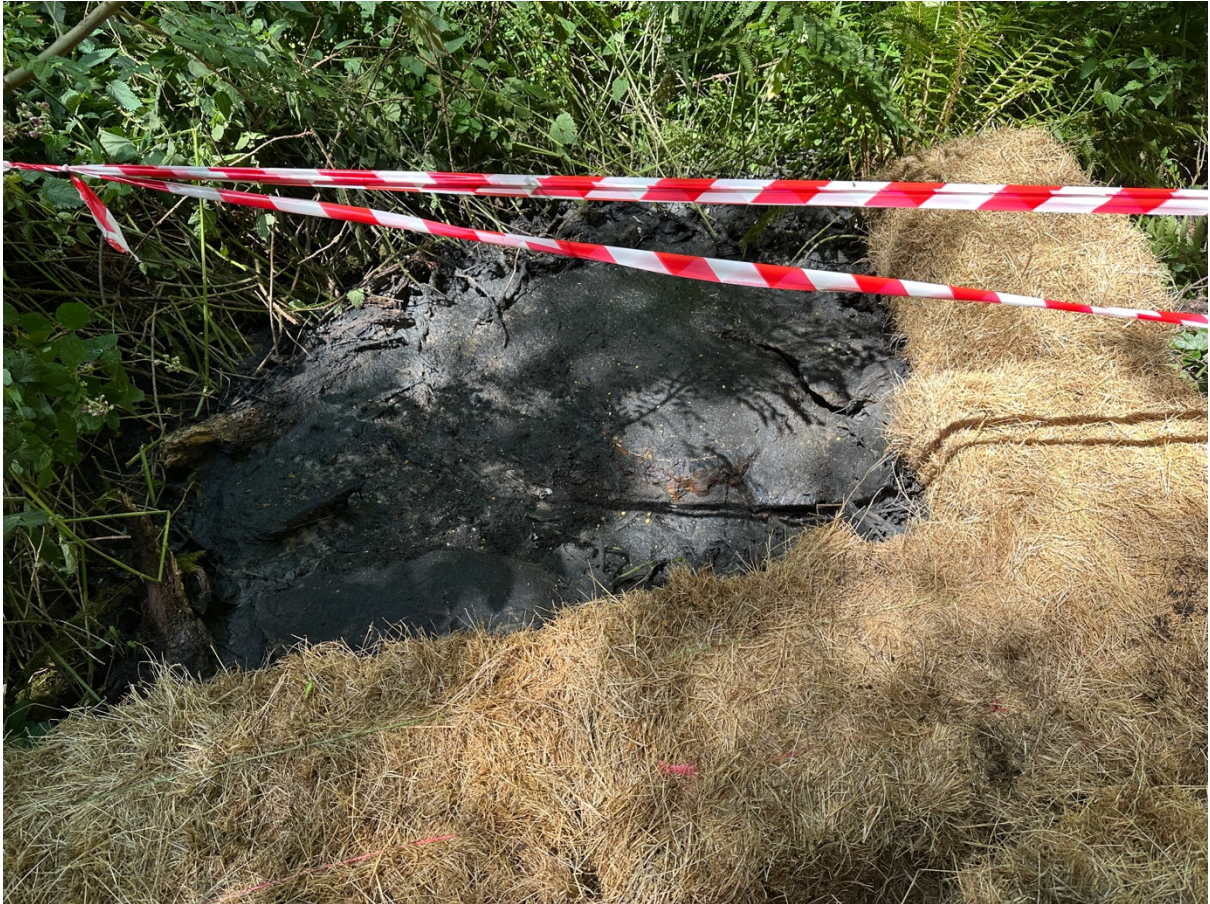
Several hay bales were present and appeared to have been placed to contain or direct the discharge. APFN was informed that these had apparently been placed by DCWW within the previous 24 hours.

DCWW staff and Drainforce contractors were present on site. APFN observed Drainforce undertaking jetting / flushing of the pipe. This produced a very loud noise and was followed by the release of thick black sludge from the manhole area and around the hay bales.

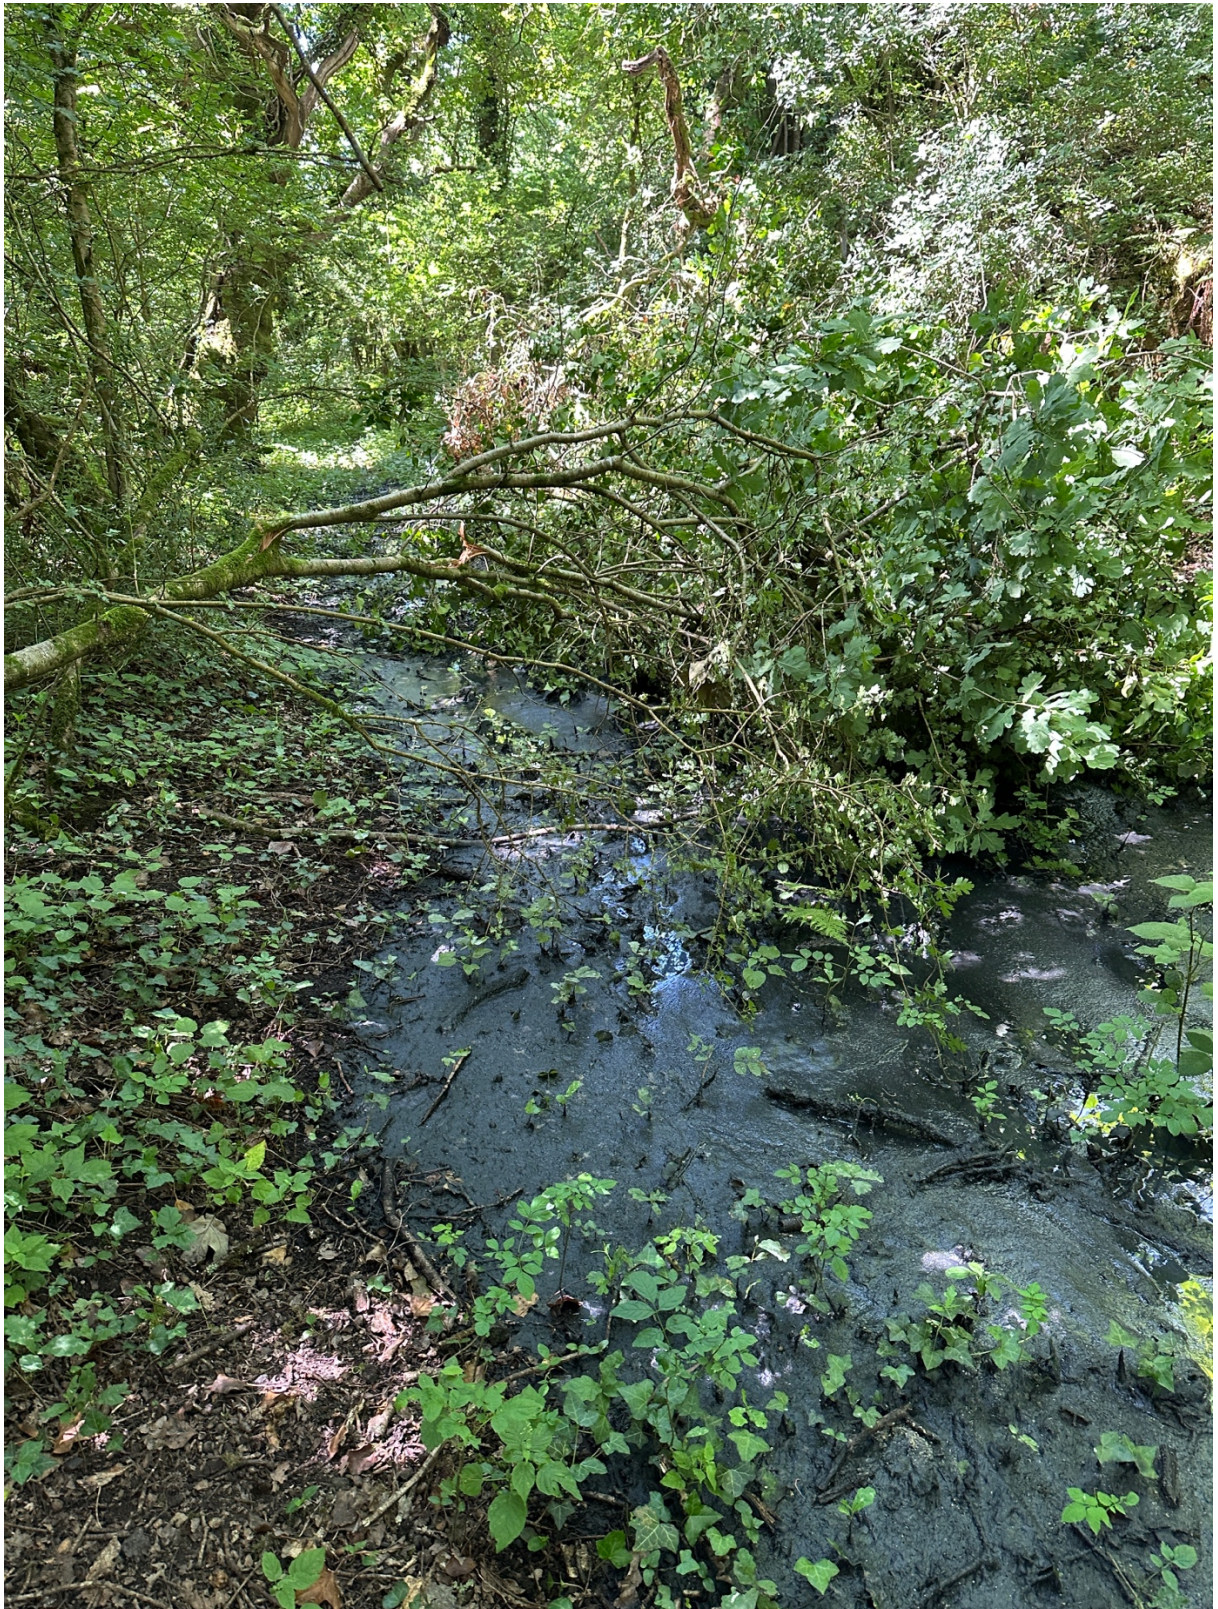
This black sludge washed over the public footpath. APFN photographed and videoed the material in situ. The sludge appeared to be approximately 5–8 inches deep in places. After the jetting activity, the active discharge appeared to stop.

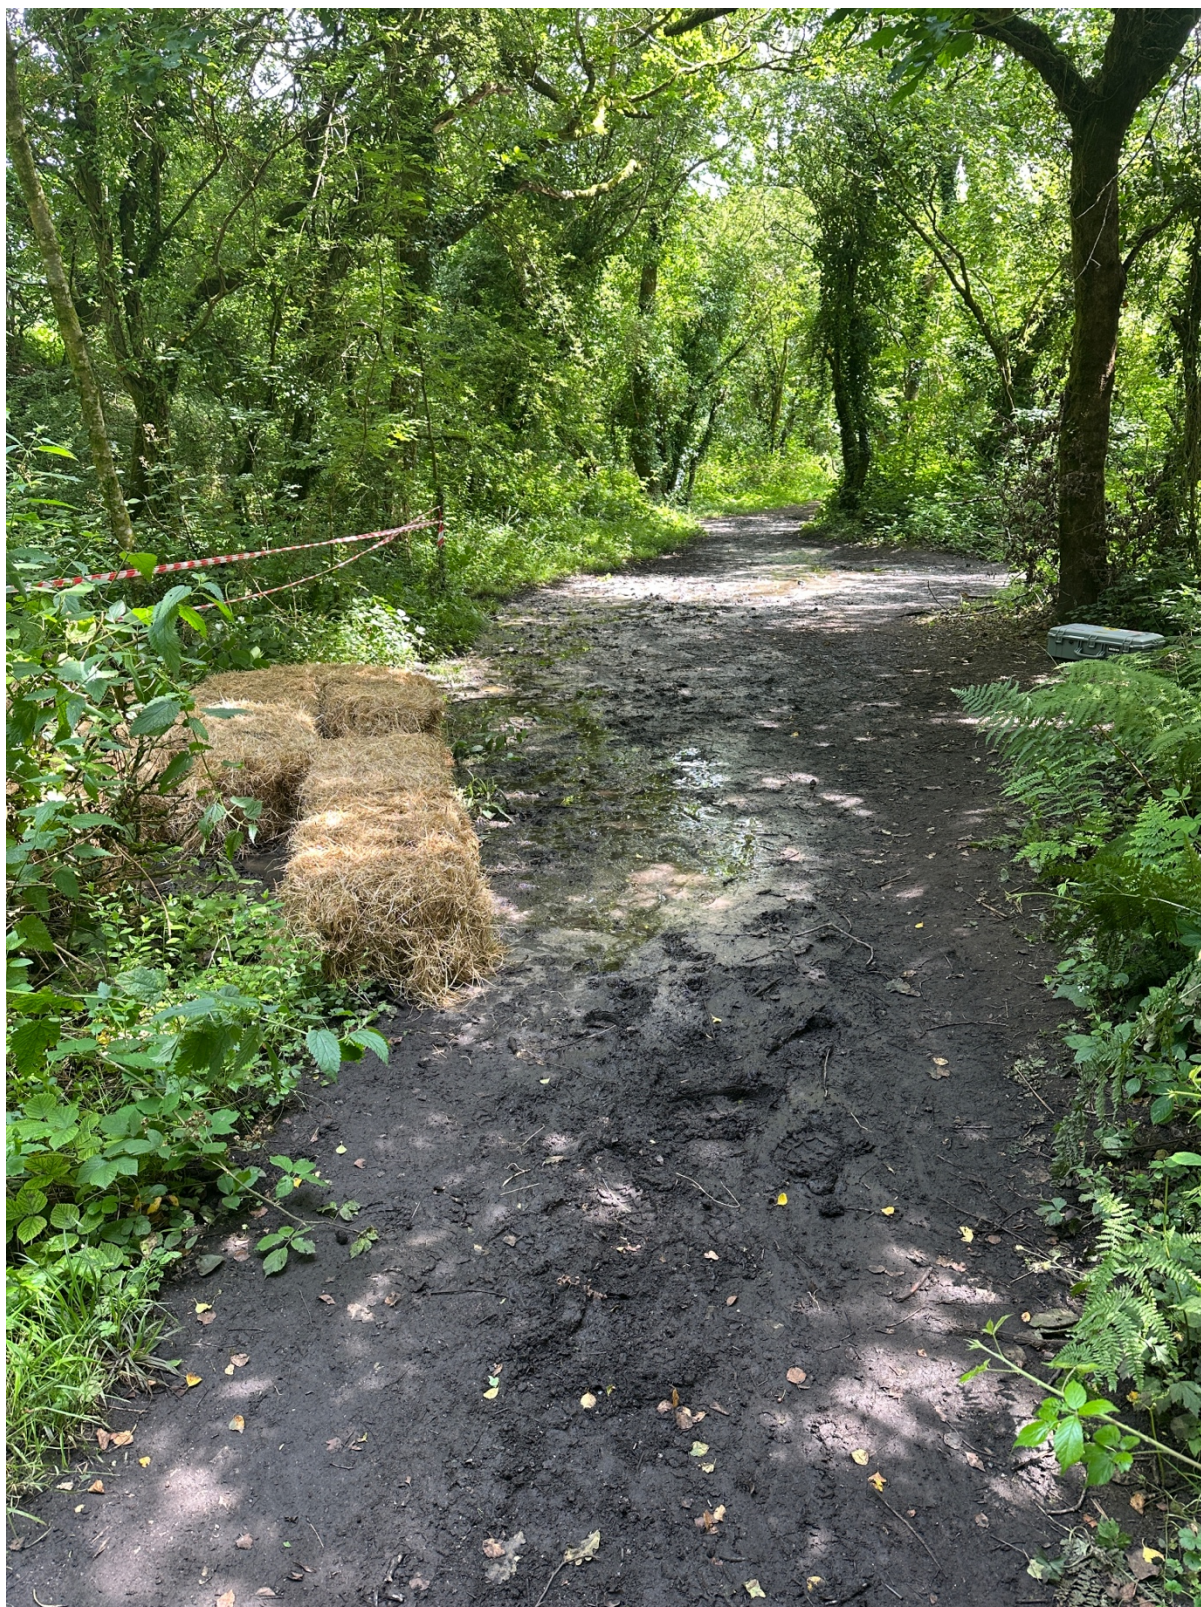
APFN also observed signs of sewage-related material on or near the public footpath over an estimated distance of approximately 50 metres.
