APFN Site Visit Report
8 June 2026
Afon Cynffig / Kenfig River Pollution
Incident

Prepared by A Peace for Nature

This briefing summarises independent environmental monitoring and site observations undertaken by A Peace for Nature on 8 June 2026 on the Afon Cynffig / Kenfig River downstream of the Marlas STW SPS outfall, North Cornelly.

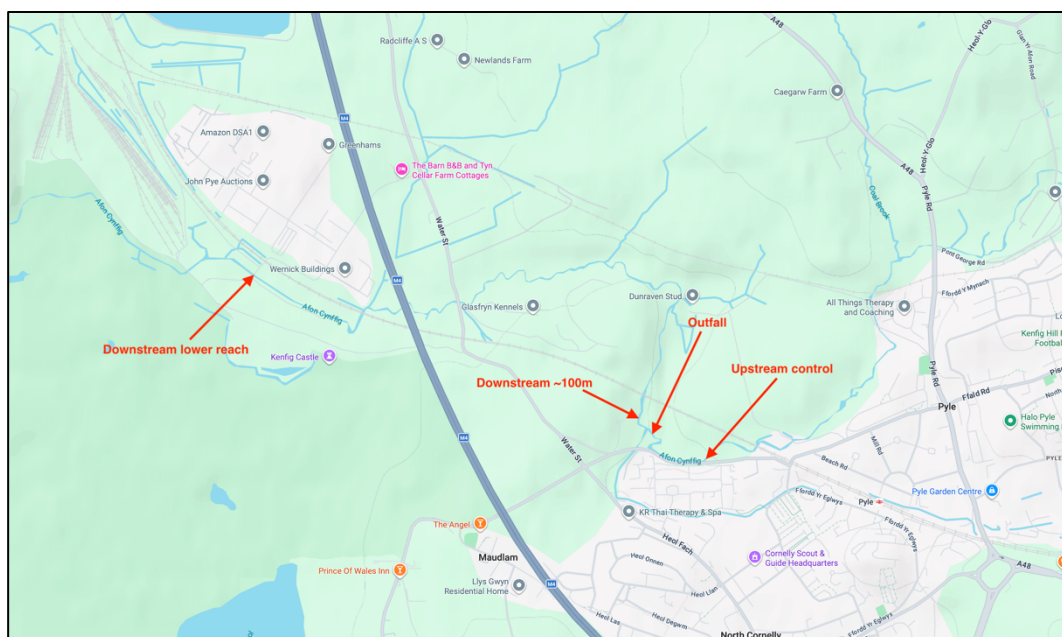
Figure 1 APFN Sample locations

Upstream control	Upstream of the affected discharge reach ~300-400m
APFN outfall sample location	Marlas STW SPS outfall discharge
Downstream	~100 m downstream from the outfall
Downstream lower reach	~3.2 km
